## Project Case Study: Alderman Tooling Ltd Plymouth, UK

**Aldermans is one of the South West's most highly respected metalwork engineers. The loading bay at its busy Plymouth factory now has a repaired and upgraded floor joint, which is benefitting staff and business efficiency.**

### Permaban Signature AR: the permanent joint repair

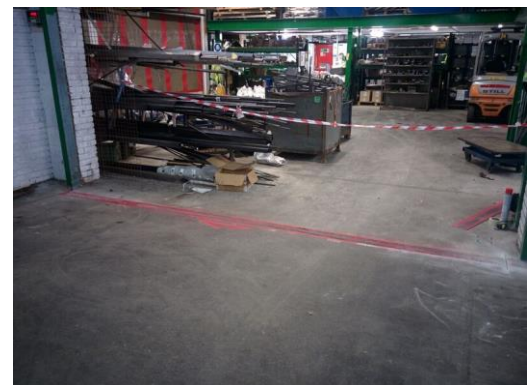
The loading bay and stores are located in an extension area at the rear of the building, accessed from the factory through just one doorway. As a result, the straight joint in the concrete floor was subject to the harsh impact forces of directional traffic as the forklift crossed the joint.

Although the forklift was fitted with pneumatic tyres, the constant use was still enough to cause damage to the joint. Although previous repairs had been undertaken, these were unsatisfactory and further damage occurred.

The joint repair at Aldermans was undertaken on 16<sup>th</sup> December 2015, and took just 15 hours to complete, so the area was out of use for less than a day. The damaged portion of floor was cut away, creating a channel into which the Signature AR joint was placed. No attachment was needed to the surrounding floor. The repair area was 4.8m long, which constituted four complete 1m lengths of Signature AR, and an additional length cut to size, all designed to be clipped together easily.

The channel was filled with a bonding agent and repair mortar; then the repair area was ground so that the finish was completely seamless with the surrounding floor.
